TEST REPORT No. CTI-PA 3017-1

Applicant: SCHIRTEC AG
 Ignaz-Köck-Straße 10
 1210 Wien

Type of test item: Air terminal, Model: S-AM

Selective tests according to EN 50164-1:2008, clause 6.3 Electrical test / Classification H

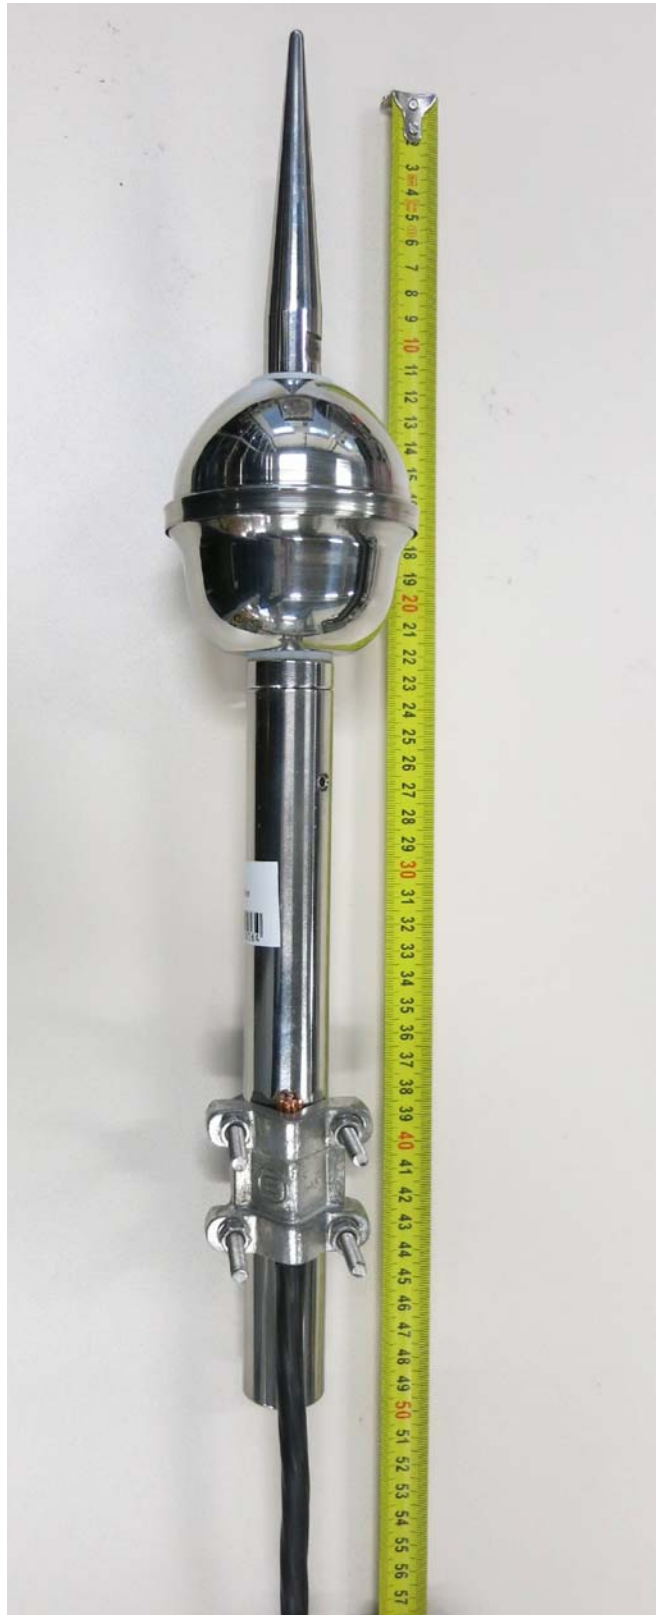
Test sample before the tests.

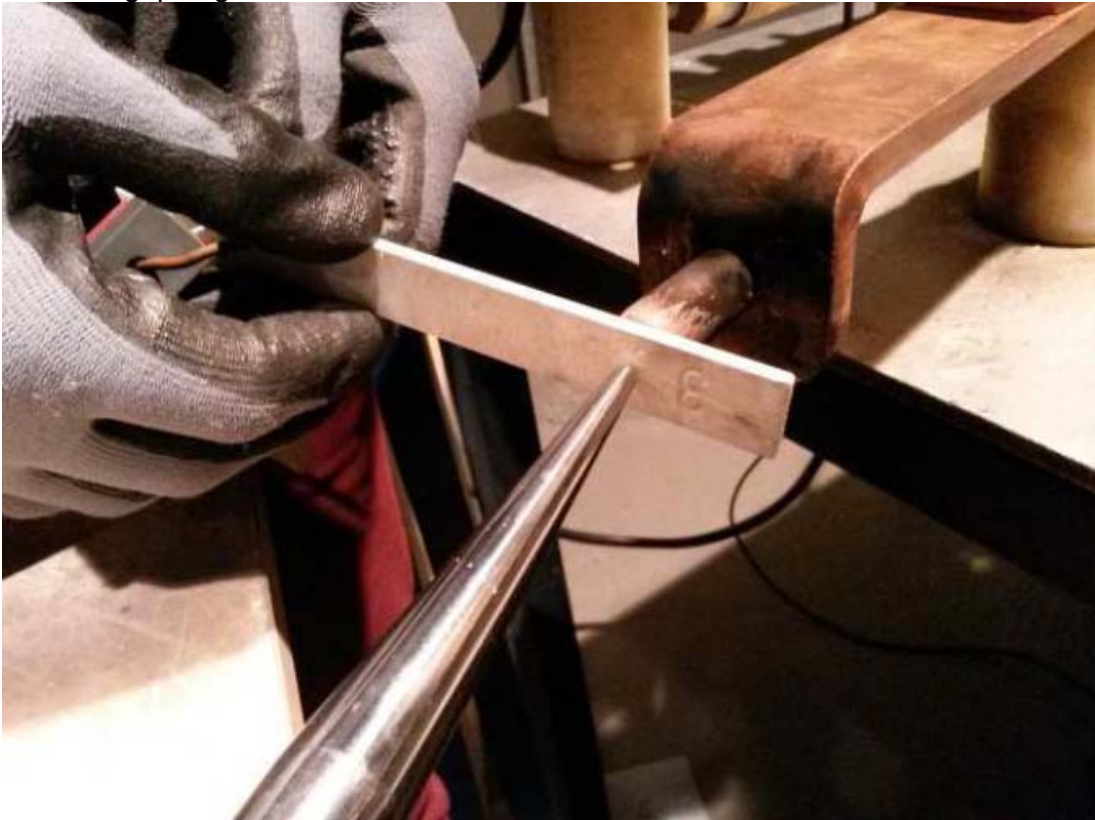
Test arrangement and generator connection

3mm arc gap to generator

The air terminal tip was connected via a minimum air gap of approx. 3mm to the other output terminal of the generator.

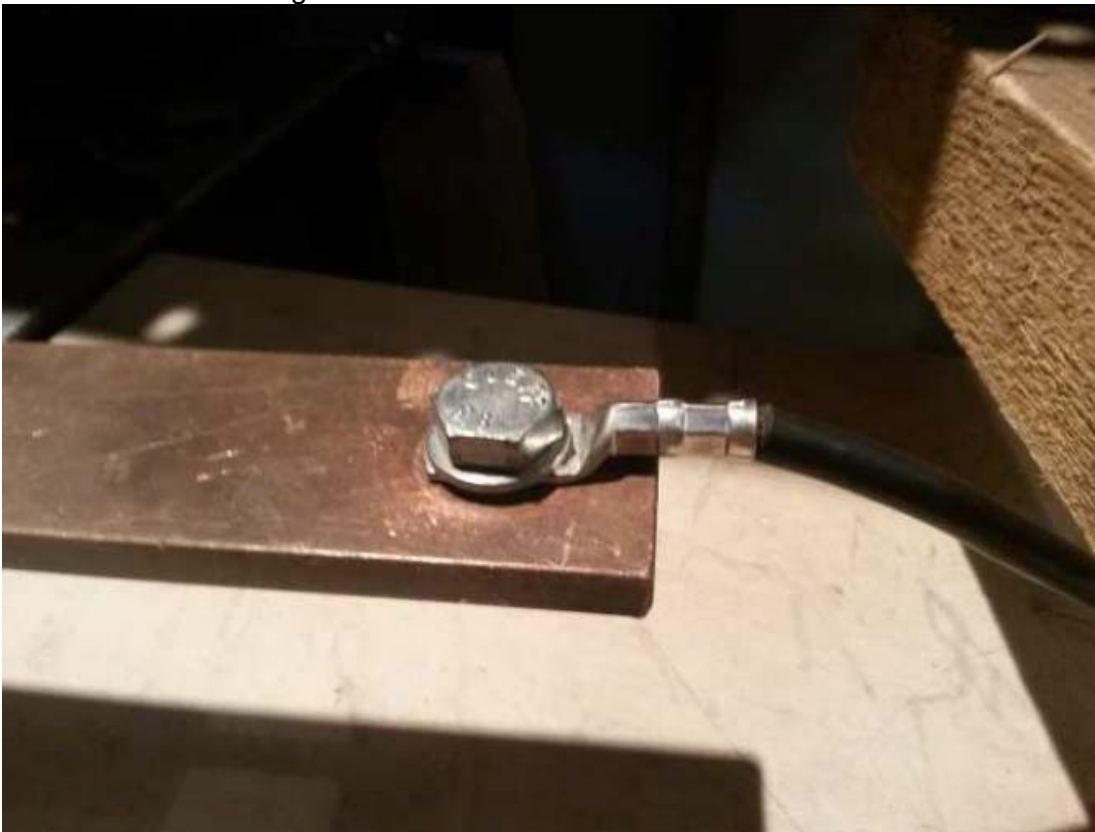
Ground connection to generator

The air terminal bottom tube was connected via a short down-conductor of appropriate cross section to the impulse generator. The connection between air terminal and down-conductor was done by use of a special clamping unit provided by the manufacturer.

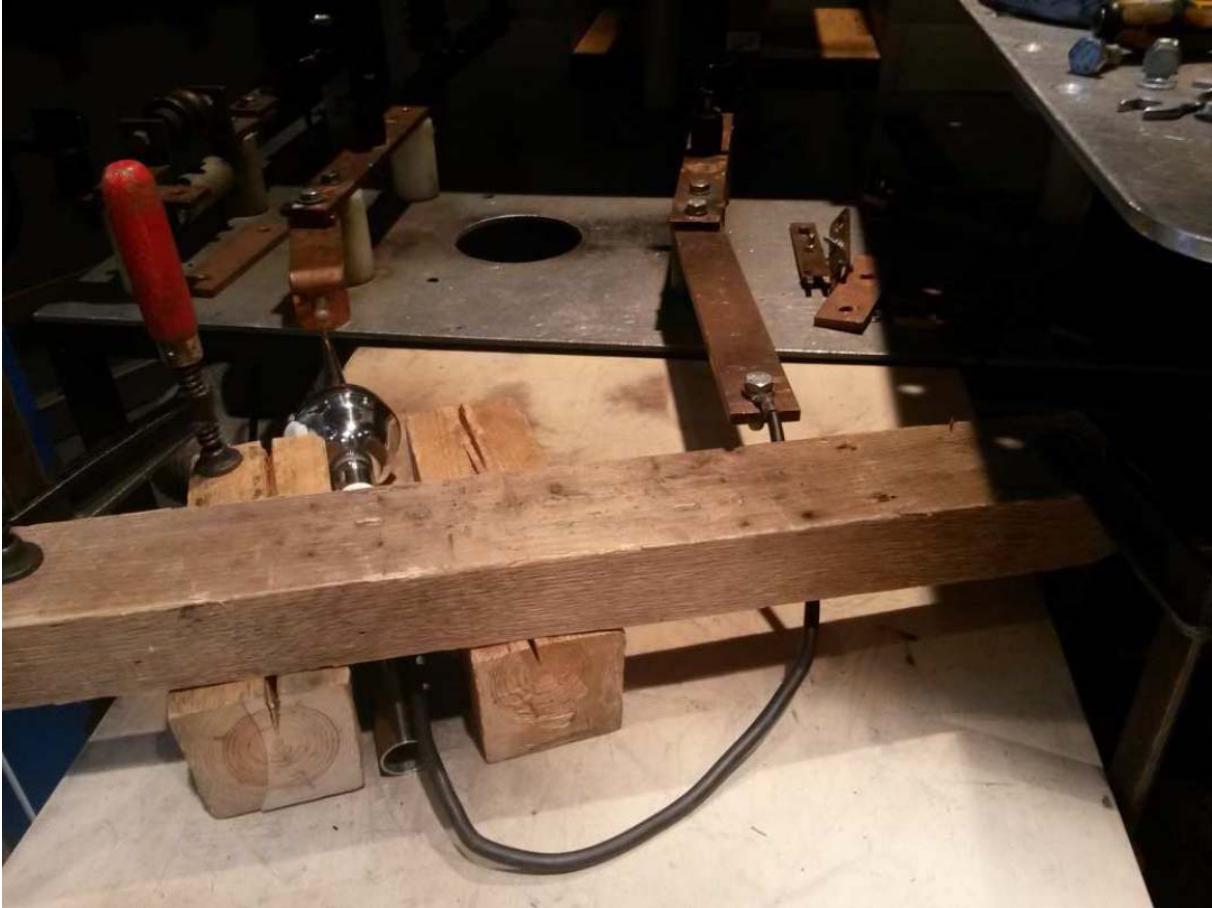
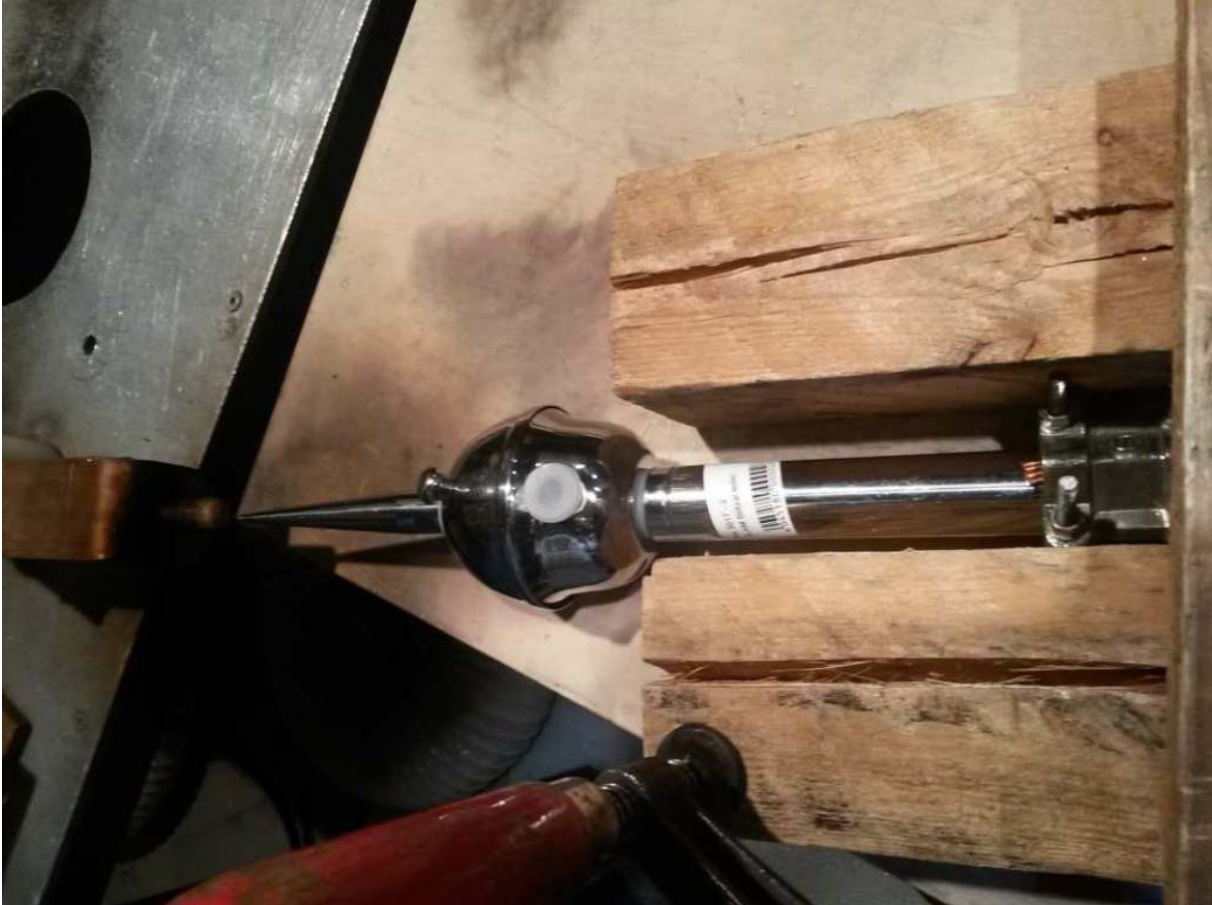
Sample connected to generator

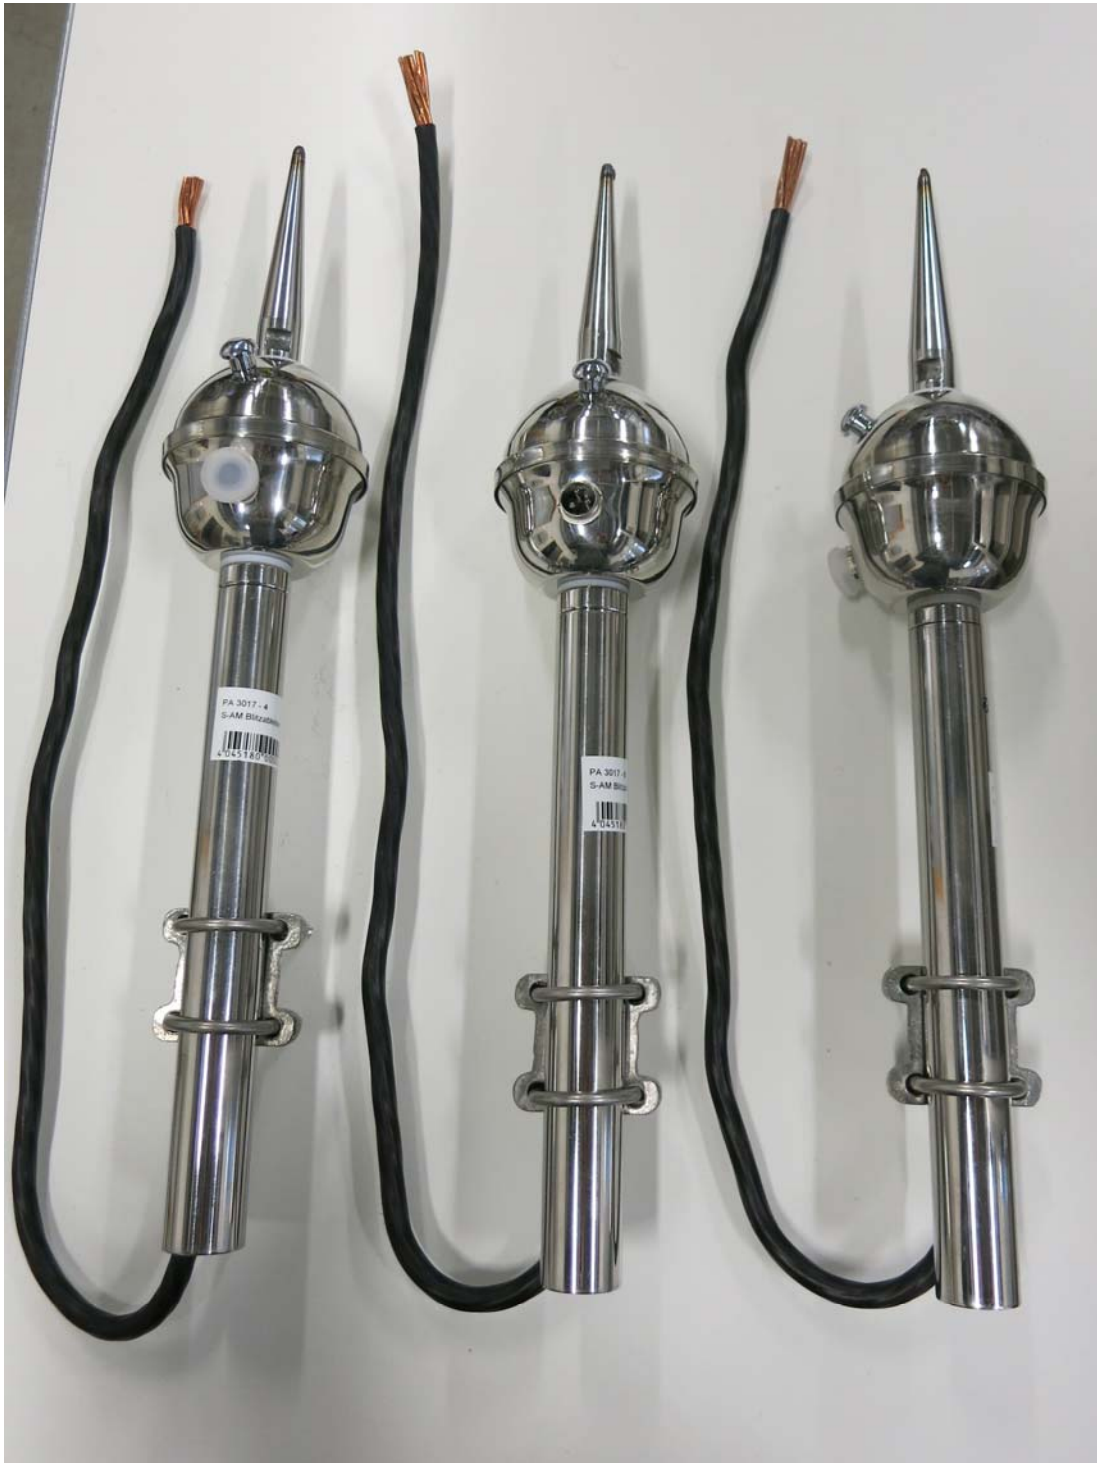
Test samples after the tests:

Tips of test samples showed discoloration and current marks due to arc.

Visual inspection showed discoloration of tips and current marks due to arc, but no physical damage, no loose parts and no deformation. Photos of the test samples after application of impulses are shown in ANNEX 3.

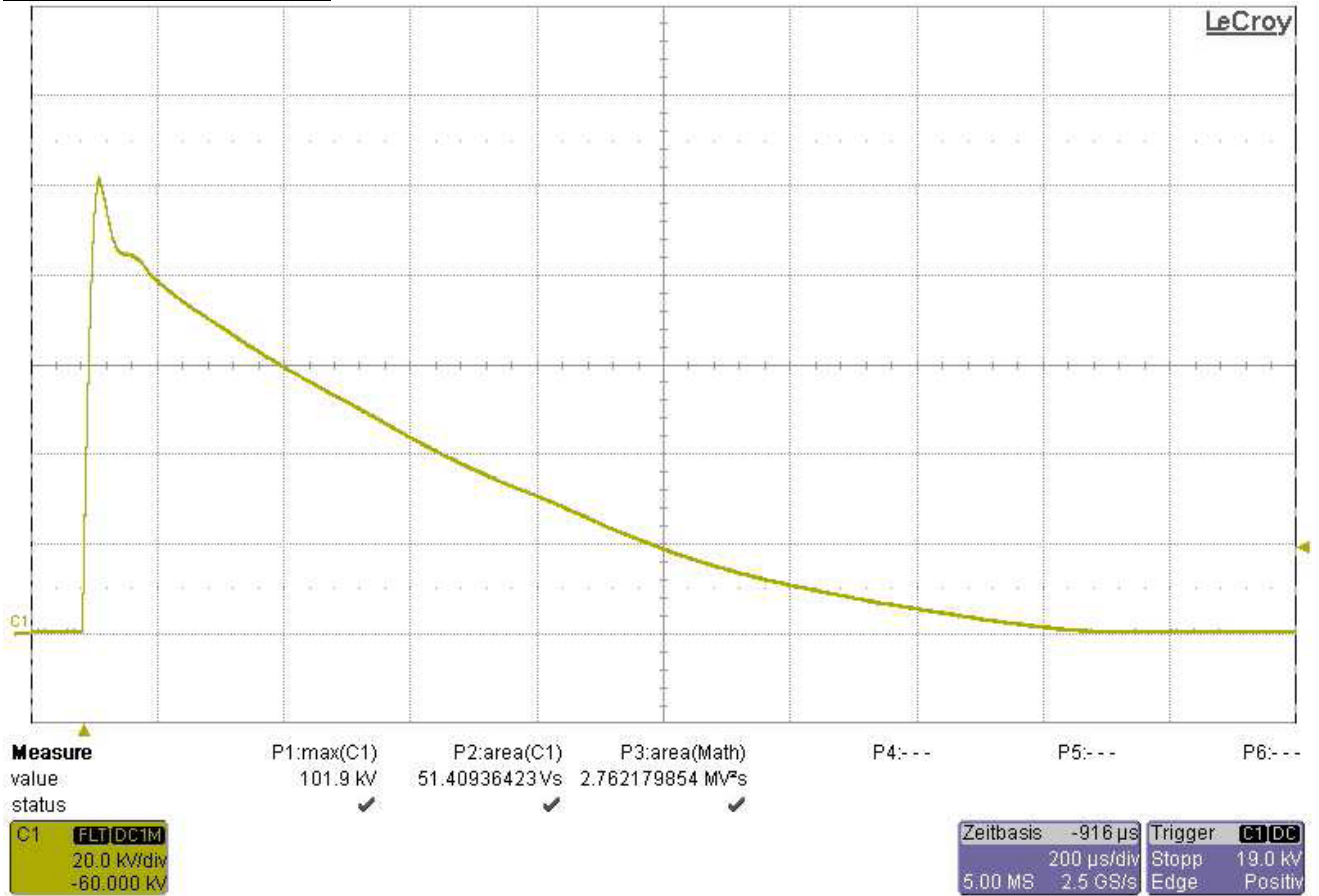
Sample 1, First impulse

$I_{imp} = 101,9kA$, $Q = 51,4As$, $W/R = 2,76MJ/\Omega$

I_{imp} [kA]	Q [As]	W/R [MJ/ Ω]
Sample 1			
First Impulse	101,9	51,4	2,76
Second Impulse	101,5	47,4	2,45
Third Impulse	103,8	48,2	2,59
Sample 2			
First Impulse	102,2	50	2,63
Second Impulse	101,5	51	2,68
Third Impulse	104	50	2,69
Sample 3			
First Impulse	104,2	52,6	2,8
Second Impulse	101,8	51,6	2,71
Third Impulse	104,2	51,7	2,79

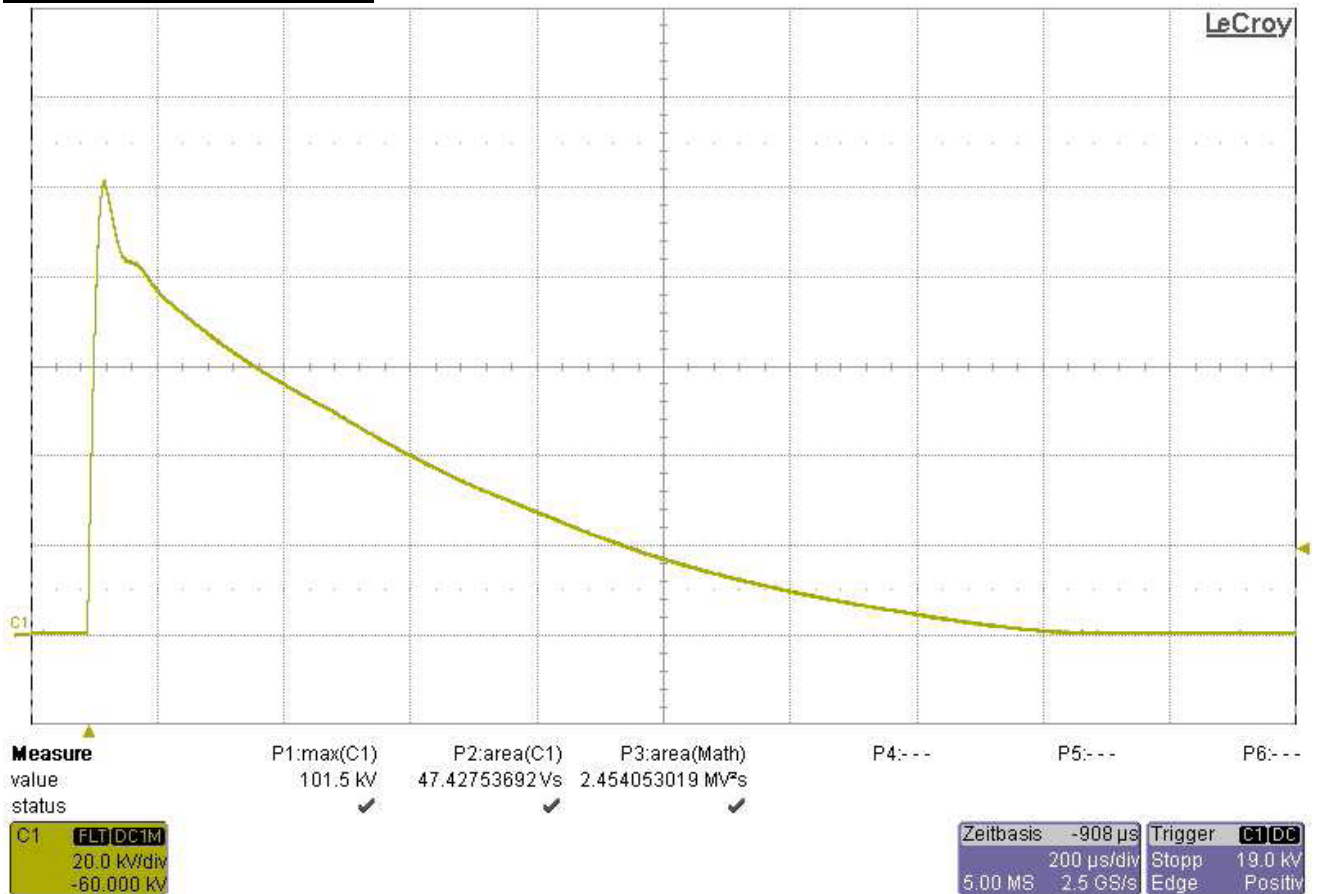
Sample 1, Second impulse

$I_{imp} = 101,5kA$, $Q = 47,4As$, $W/R = 2,45MJ/\Omega$

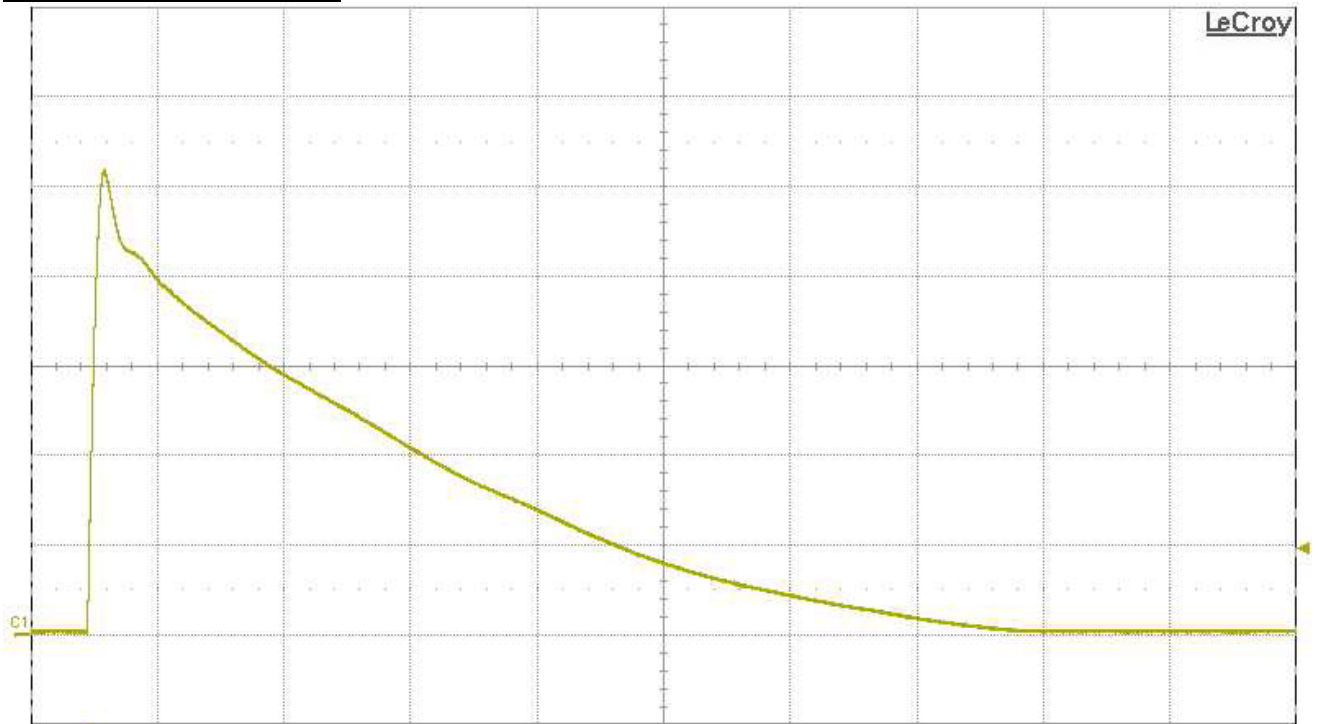
Sample 1, Third impulse

Measure	P1:max(C1)	P2:area(C1)	P3:area(Math)	P4:---	P5:---	P6:---
value:	103.8 kV	48.16565865 Vs	2.593477057 MV ² s			
status:	✓	✓	✓

$I_{imp} = 103,8\text{kA}$, $Q = 48,2\text{As}$, $W/R = 2,59\text{MJ}/\Omega$

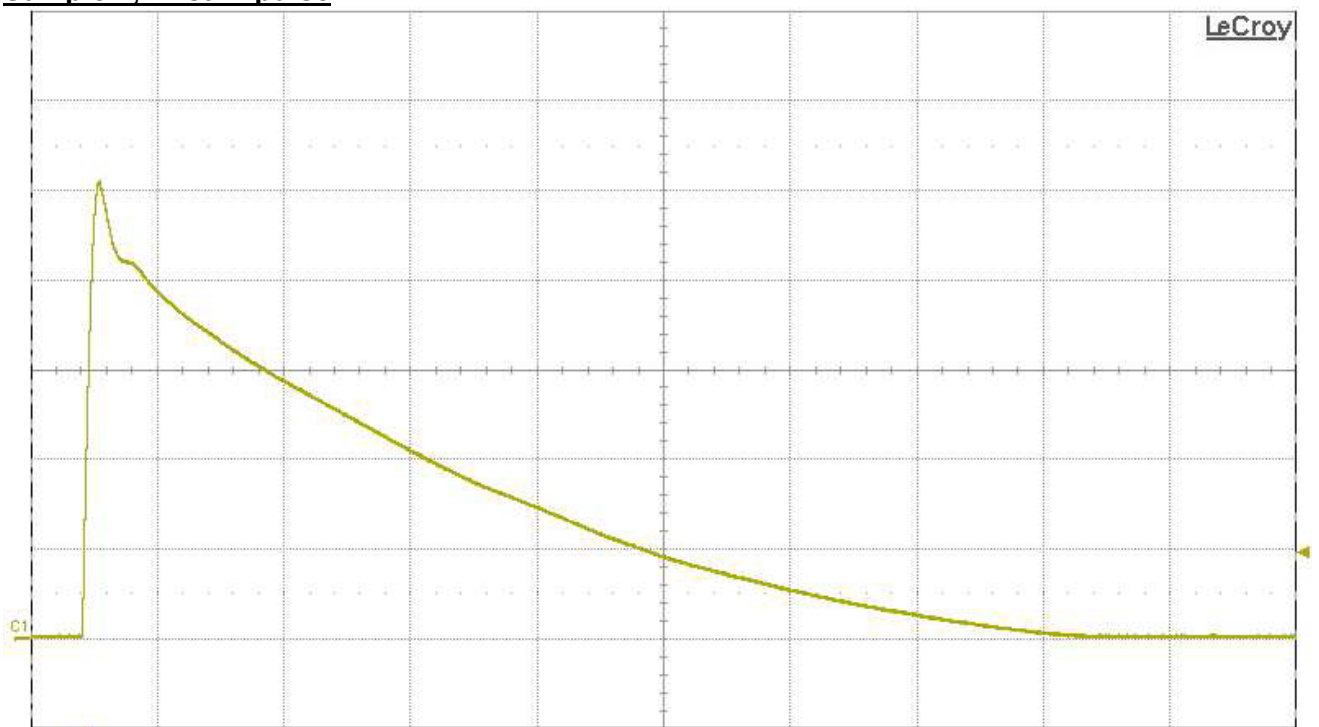
Sample 2, First impulse

Measure	P1:max(C1)	P2:area(C1)	P3:area(Math)	P4:---	P5:---	P6:---
value:	102.2 kV	49.95968950 Vs	2.630297589 MV ² s			
status:	✓	✓	✓

$I_{imp} = 102,2\text{kA}$, $Q = 50\text{As}$, $W/R = 2,63\text{MJ}/\Omega$

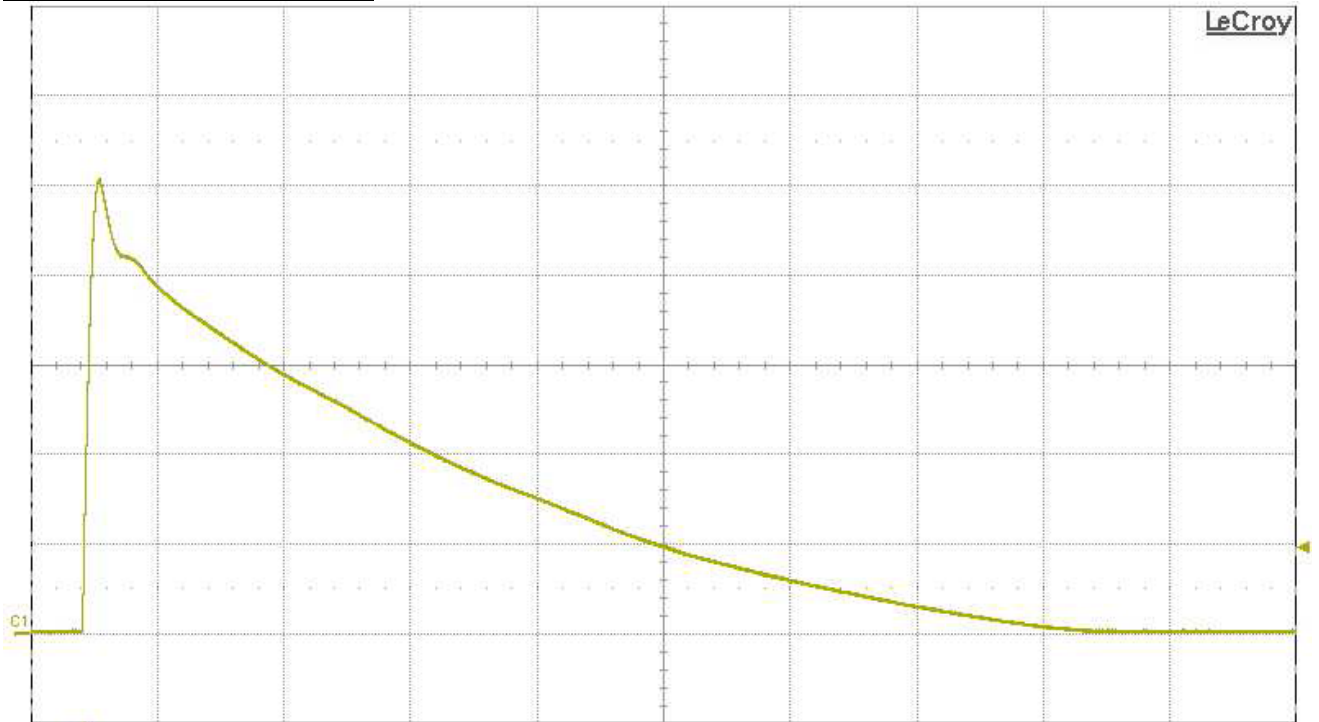
Sample 2, Second impulse

Measure	P1:max(C1)	P2:area(C1)	P3:area(Math)	P4:---	P5:---	P6:---
value	101.5 kV	50.99028849 Vs	2.677032822 MV ² s			
status	✓	✓	✓

$I_{imp} = 101,5kA, Q = 51As, W/R = 2,68MJ/\Omega$

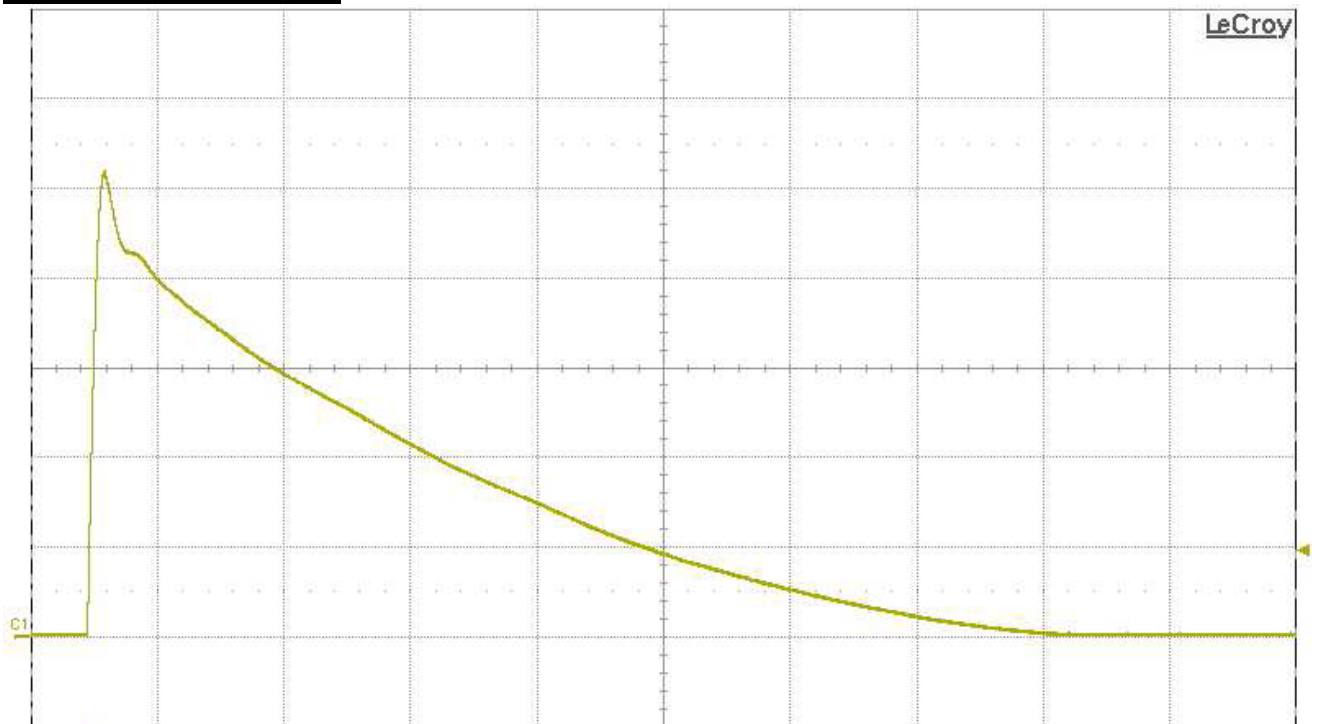
Sample 2, Third impulse

Measure	P1:max(C1)	P2:area(C1)	P3:area(Math)	P4:---	P5:---	P6:---
value	104.0 kV	49.98418474 Vs	2.691956188 MV ² s			
status	✓	✓	✓

$I_{imp} = 104kA, Q = 50As, W/R = 2,69MJ/\Omega$

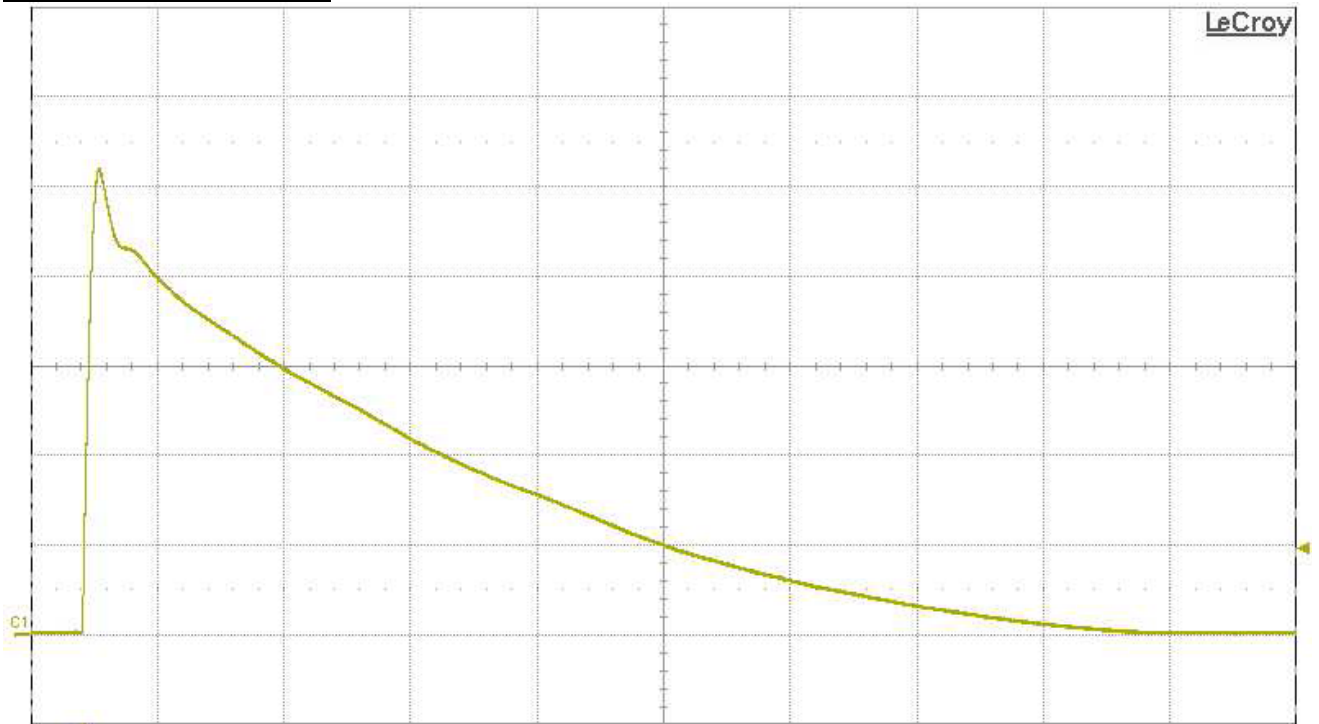
Sample 3, First impulse

Measure	P1:max(C1)	P2:area(C1)	P3:area(Math)	P4:---	P5:---	P6:---
value:	104.2 kV	52.55740402 Vs	2.823271081 MV ² s			
status:	✓	✓	✓

$I_{imp} = 104,2\text{kA}$, $Q = 52,6\text{As}$, $W/R = 2,82\text{MJ}/\Omega$

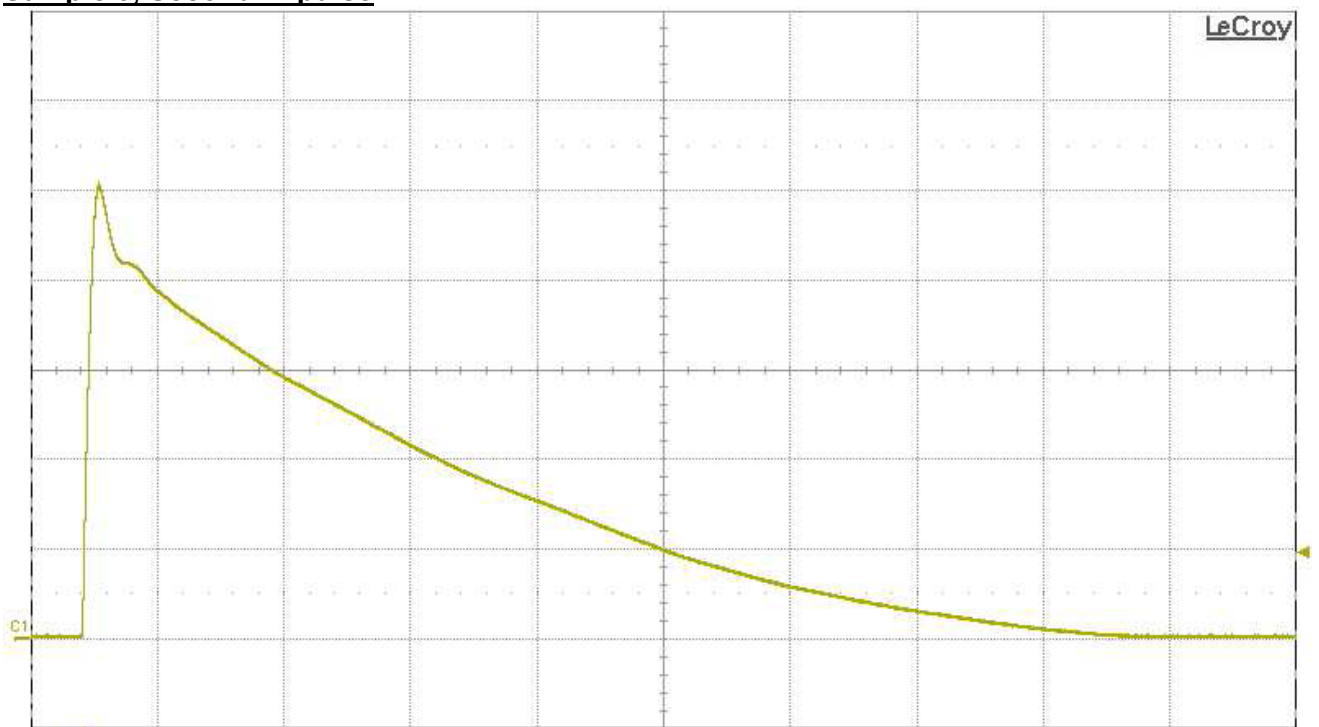
Sample 3, Second impulse

Measure	P1:max(C1)	P2:area(C1)	P3:area(Math)	P4:---	P5:---	P6:---
value:	101.8 kV	51.56879258 Vs	2.714972674 MV ² s			
status:	✓	✓	✓

$I_{imp} = 101,8\text{kA}$, $Q = 51,6\text{As}$, $W/R = 2,71\text{MJ}/\Omega$

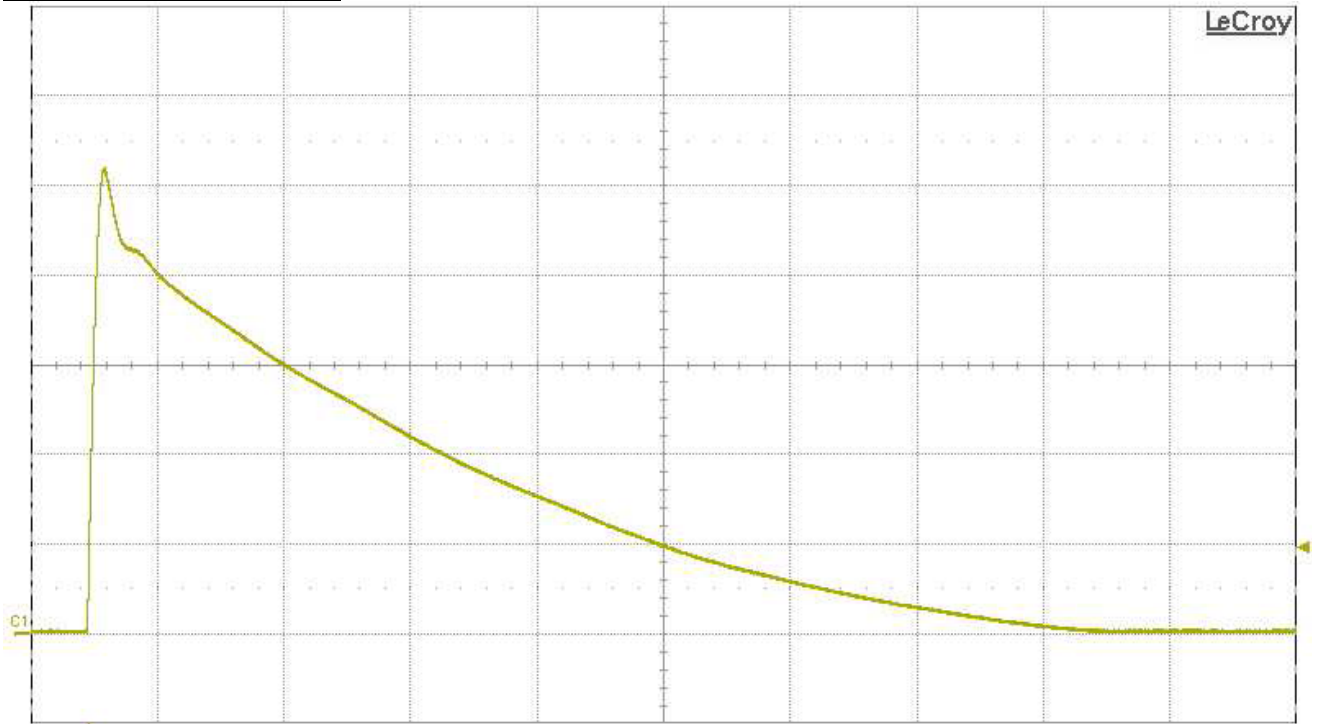
Sample 3, Third impulse

Measure	P1:max(C1)	P2:area(C1)	P3:area(Math)	P4:---	P5:---	P6:---
value	104.2 kV	51.66799481 Vs	2.787725426 MV ² s			
status	✓	✓	✓

$I_{imp} = 104,2\text{kA}$, $Q = 51,7\text{As}$, $W/R = 2,79\text{MJ}/\Omega$
